SERVICE BULLETIN

PURPOSE : CORRECTION	ISSUE NO. : MSB-13EXL35-501	DATE : 2013-05-31
SUBJECT : ASC TROUBLESHOOTING		<Destination/Model> (EUR/MMAL/NZ) <M/Y> 13-14
GROUP : ASC(Gr.35C)		MIRAGE/SPACE STAR(A03A)

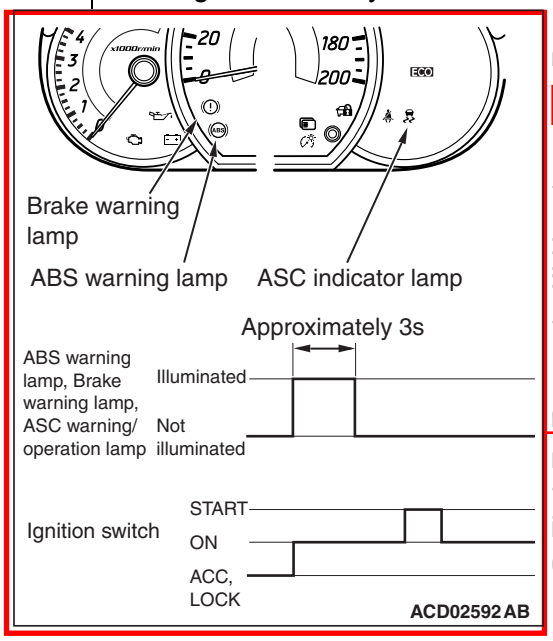
Correct

1. ASC controls brake pressure by the assistance of ECU. The symptoms described in the chart below may occur during the normal ASC operation, and they do not indicate any sign of malfunction.

Symptoms	Description of symptoms
• When the ASC operates, the operating noise is generated from the motor. (Squeak noise) • Noise is generated from the brake pedal together with the vibration. (Gride noise) • When ABS operates, the system repeats the activation and deactivation. At this time, the noise is generated from the chassis components. (Clonk: Suspension, Squeaky: Tyres)	These noises are generated when the system and brake pedal operate normally, and they do not indicate any sign of malfunction.
• A slight shock may be felt when depressing the brake pedal	This noise is generated when the system operation check (startup check performed at the vehicle speed which is a few km/h higher than the predetermined vehicle speed) is performed, and it does not indicate malfunction.
