SERVICE BULLETIN

PURPOSE : CORRECTION	ISSUE NO. : MSB-15EXML51-501	DATE : 2015-12-01
SUBJECT : Error in writing of the adjustment of the jet type washer nozzle injection position		<DESTINATION/MODEL> As per attached sheet 1 <M/Y> 13-16
GROUP : Gr:51(Exterior)		OUTLANDER(GF0W)/ OUTLANDER PHEV(GG0W)

WINDSHIELD WASHER FLUID EJECTION CHECK

Adjustment of the jet type washer nozzle injection position

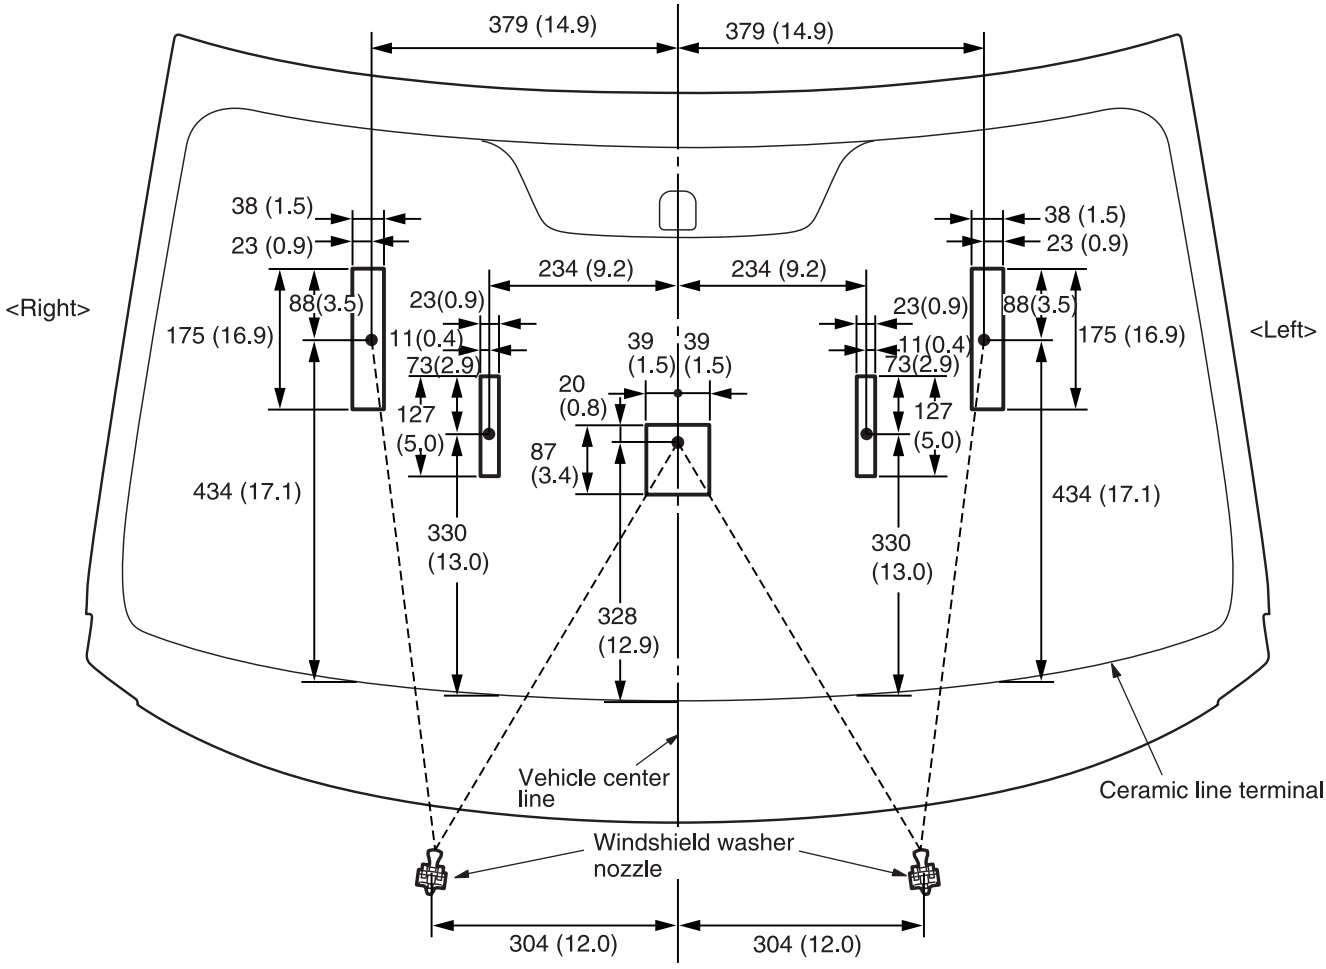
Attached sheet 3

<Incorrect>

~~Replace the washer nozzle if it does not spray washer fluid onto the shown area.~~

1. Check whether washer fluid is sprayed as shown.

Be careful not to break a pin inside the washer nozzle when you adjust it.

2. If the spray pattern shown is not satisfied, use a pin (thinner than 0.7 mm in diameter) to adjust the washer nozzle.
