| **Newsletter** | **ENL-19-016-SR Revision_IO** |
| **Model** | **L200 / Triton (KK0T, KL0T)** |
| **Subject** | **Side Step Shade drop-off due to rivet fracture** |
| | **(REF. MMC: SSI 1904009)** |

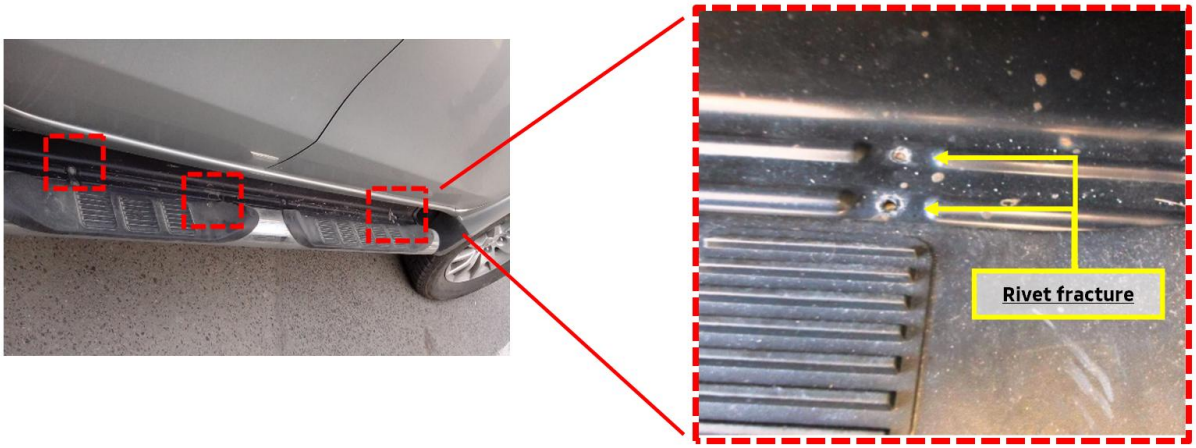
The rivets fixing the side step shades may corrode and fracture. In case all the rivets fracture, the side step shades may drop off from the vehicle causing a risk of a vehicle accident.

Remove all the rivets and fix the side step shades with new bolts and nuts instead.
Refer to the attached repair procedure.

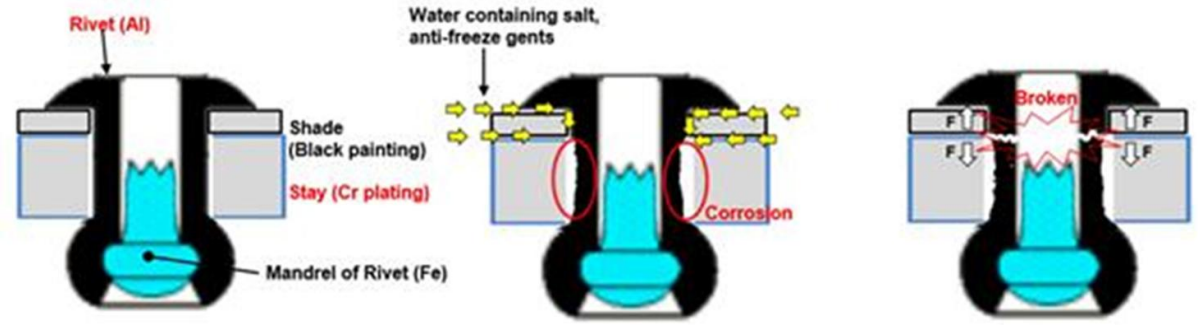
The rivets corrode and fracture especially under the environmental usage condition where these are exposed to salt or anti-freeze agent.

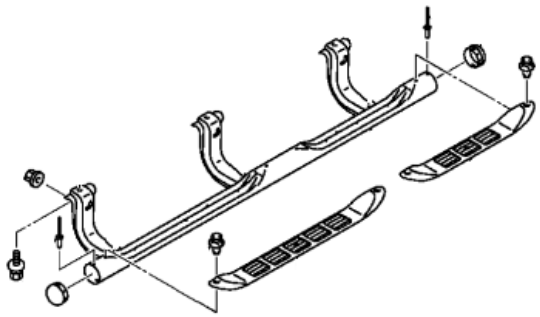
Original pipe type

Inspect whether the original pipe type side steps are installed before continuing to the repair procedure.

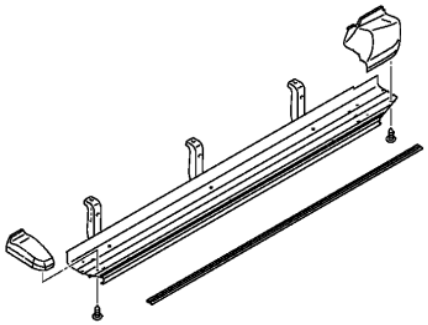
Plate type since 17MY

The side steps have been changed to another type since 17MY production.
