SERVICE BULLETIN

MITSUBISHI MOTORS

PURPOSE : INFORMATION	ISSUE NO. : MSB-11E11-006	DATE : 2011-11-20
SUBJECT : ID MARK ON CONNECTING ROD AND CRANKSHAFT BEARINGS FOR 3A9 AND 4A9 ENGINES		<MODEL> (EUR) Vehicles equipped with 3A9 or 4A9 engine / <M/Y> ALL
GROUP : ENGINE

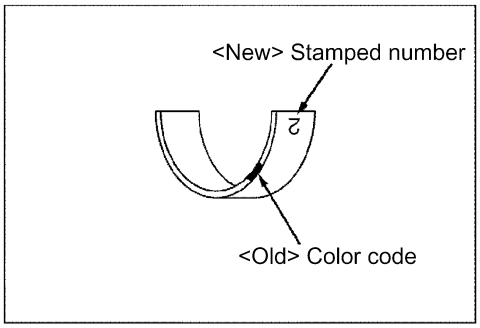
The identification marking is changed from a paint color code to a stamped number. The location of the mark is also changed.

Connecting rod bearing	
New (stamped number)	Old (color code)
1	Blue
2	Black
3	Red
