MITSUBISHI MOTORS

SERVICE BULLETIN

PURPOSE : CORRECTION	ISSUE NO. : MSB-11E22-504	DATE : 2011-09-20
SUBJECT : DRAIN PLUGS FOR TC-SST		<MODEL> <M/Y>
GROUP : TWIN CLUTCH-SPORT SHIFT TRANSMISSION (TC-SST)		(EUR/RUSSIA/ UK(Japanese Domestic Spec.)) See following 2. Applicable Manuals table.

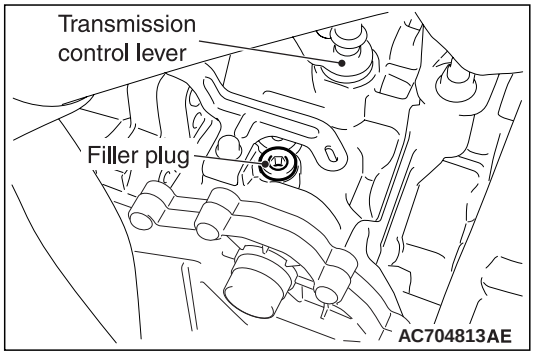
The number of drain plugs for TC-SST is changed from three to two for better serviceability. In addition, there has been an incorrect instruction (illustration) regarding the drain plugs. This Service Bulletin contains the correct information regarding the above change and correction.

6. Remove the filler plug. <Incorrect>

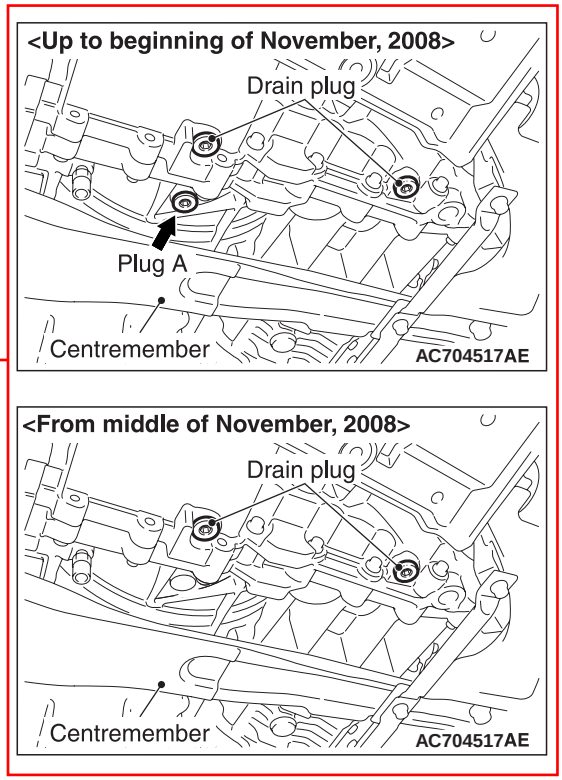
<Correct>

NOTE: Do not remove this plug when the TC-SST with plug A is received the maintenance. If this plug is removed by a mistake, install it by the same procedures as for the drain plug.
