SERVICE BULLETIN

MITSUBISHI MOTORS

PURPOSE : INFORMATION	ISSUE NO. : MSB-12E00-001A	DATE : 2012-03-28
SUBJECT : INFORMATION ON 2012 PAJERO/MONTERO		<MODEL> (EUR/RUSSIA) <M/Y> 12
GROUP : GENERAL		PAJERO/MONTERO(V80/90)

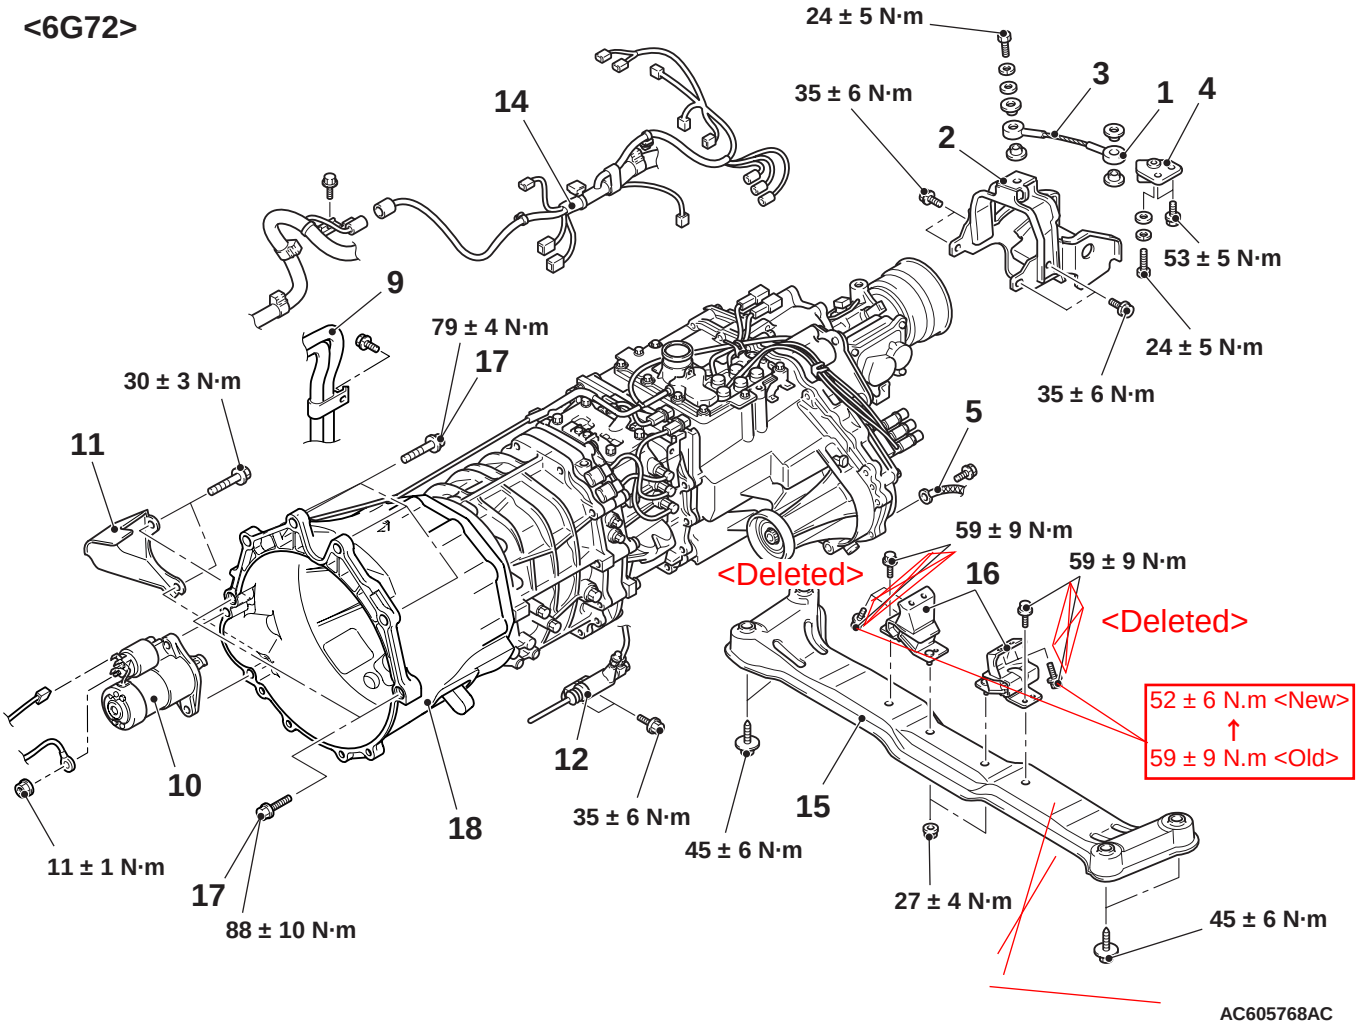
This Service Bulletin contains the information about change of the maintenance points of installation bolt of the transmission mount insulator
<kind of the installation bolt>
Washer bolt(NEW) ← Flange bolt(OLD)
<Clamping torque>
52±6 N・m(NEW) ← 59±9 N・m(OLD)
