SERVICE BULLETIN

MITSUBISHI MOTORS

PURPOSE : CORRECTION	ISSUE NO. : MSB-14EXL21-501	DATE : 2014-12-15
SUBJECT : Error in writing about the clutch switch		<DESTINATION/MODEL> (As per attached sheet 1) <M/Y> 09-15
GROUP : Gr:21(Clutch)

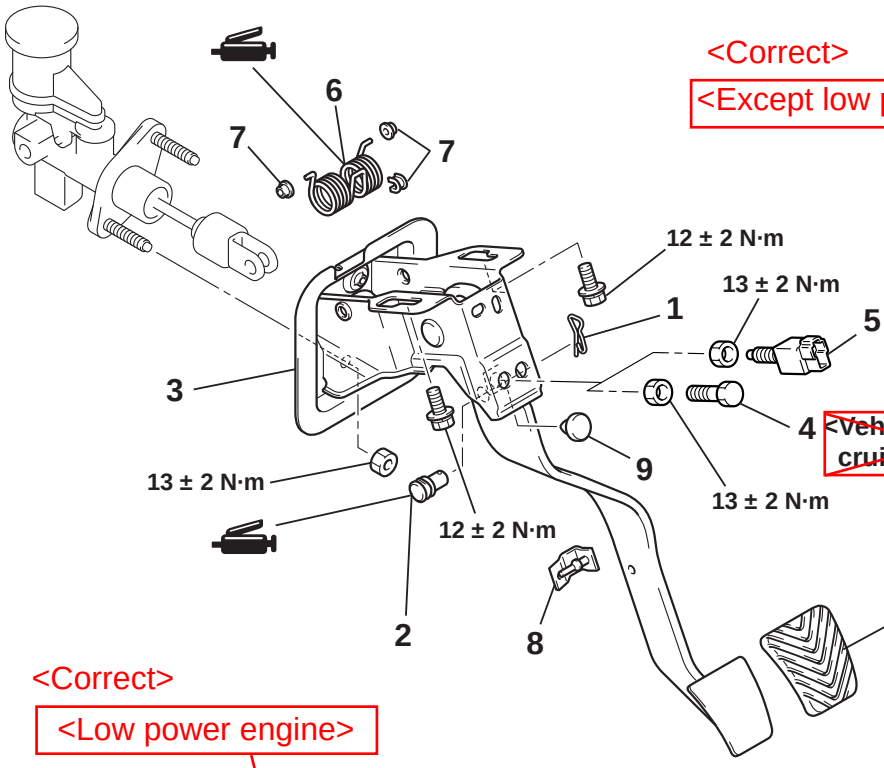
Attached sheet 2

<Correct>
<Except low power engine>
<Incorrect>
<Vehicles with cruise control>
<Vehicles without cruise control>
<Correct>
<Low power engine>

1. Snap pin
2. Clevis pin
3. Clutch pedal assembly
4. Adjusting bolt <Vehicles without cruise control> <Incorrect>
>>A<< 5. Clutch switch <Vehicles with cruise control> <Incorrect>

<Correct>
<Low power engine>

<Incorrect>

<Correct> <Except low power engine>

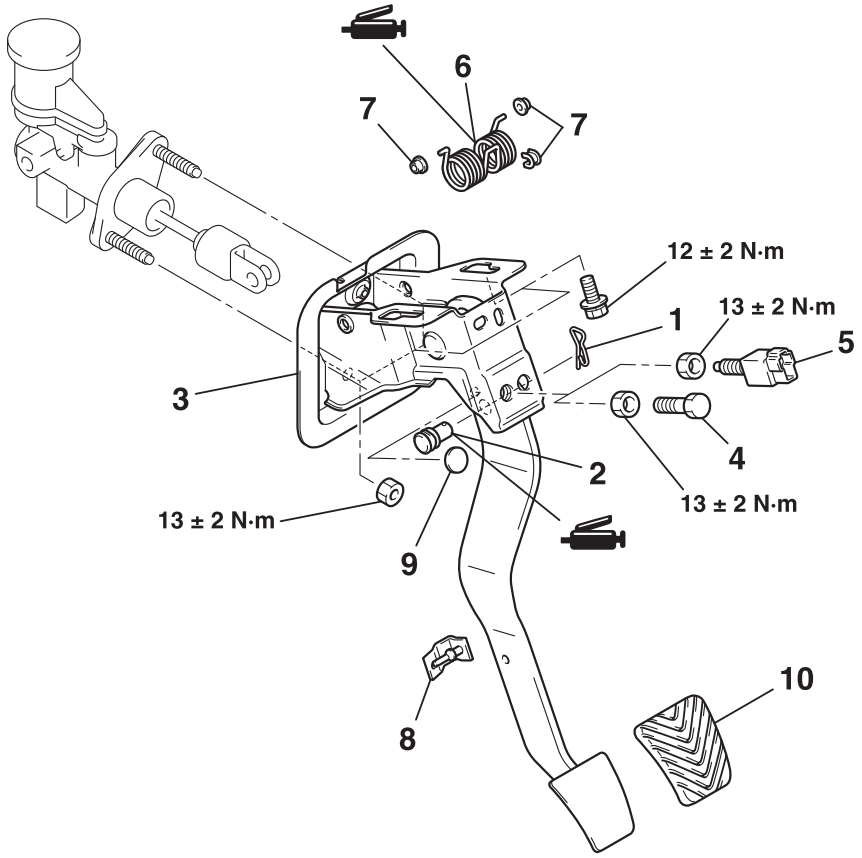
Attached sheet 3

1. Snap pin
2. Clevis pin
3. Clutch pedal assembly
4. Adjusting bolt <Vehicles without cruise control>
>>A<<Ia 5. Clutch switch <Vehicles with cruise control>

<Added>
Except 6G7,
6G7, <Added>

6G7, <Added>

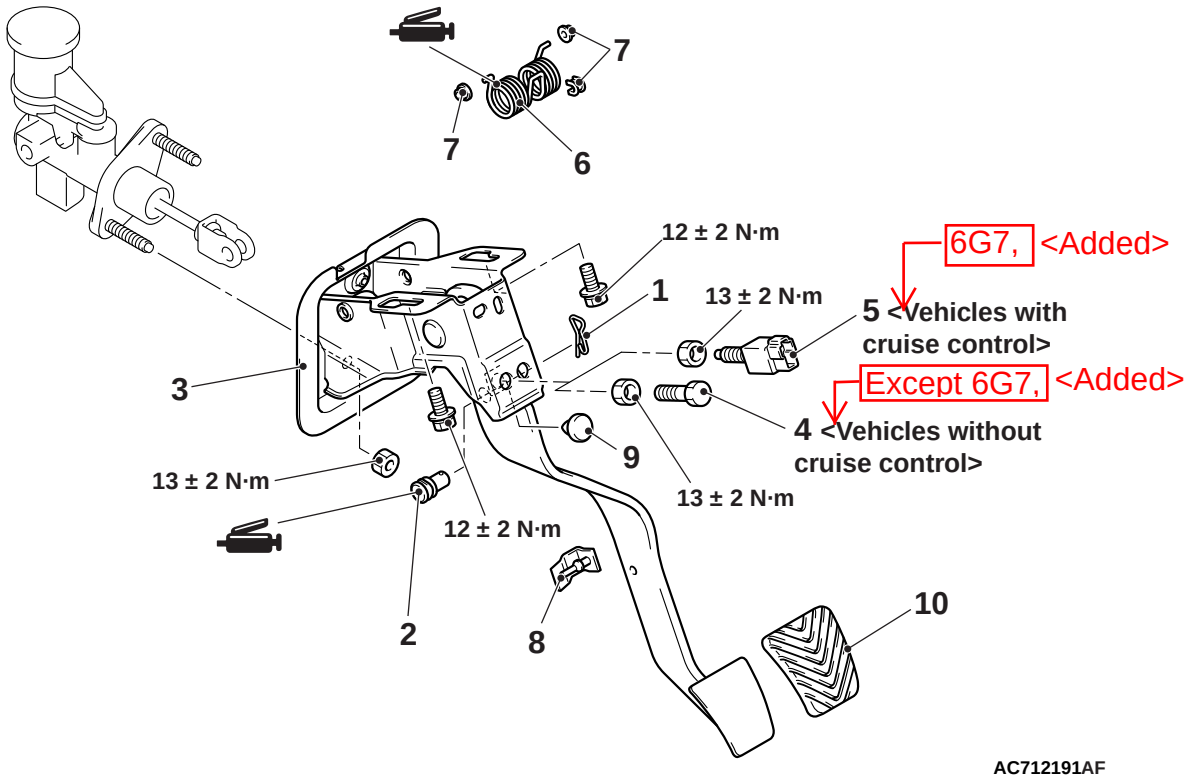
Attached sheet 4

1. Snap pin
2. Clevis pin
3. Clutch pedal assembly
4. Adjusting bolt <Vehicles without cruise control> <Added> Except 6G7,
>>A<< 5. Clutch switch <Vehicles with cruise control> 6G7, <Added>

>>A<< CLUTCH SWITCH <VEHICLES WITH CRUISE CONTROL> 6G7, <Added>
