SERVICE BULLETIN

PURPOSE : CORRECTION	ISSUE NO. : MSB-13EXL37-501A	DATE : 2013-12-25
SUBJECT : STEERING COLUMN SHAFT ASSEMBLY REMOVAL AND INSTALLATION		<Affected Destination/Model> (As per attached 1) <M/Y> 07-15
GROUP : STEERING(Gr:37)		L200/L200 SPORTERO/TRITON/STRADA/STRADA SPORTERO(KA0T/KB0T)

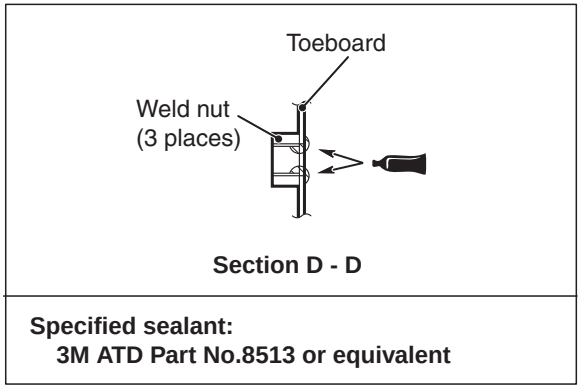
Attached sheet 2

<Correct>
<2WD (except High rider)>

<Correct>
<2WD (High rider), 4WD>

<Incorrect>
~~<2WD (High rider), 4WD>~~

<Incorrect>
~~<2WD (except High rider)>~~

Specified sealant:
3M ATD Part No.8513 or equivalent

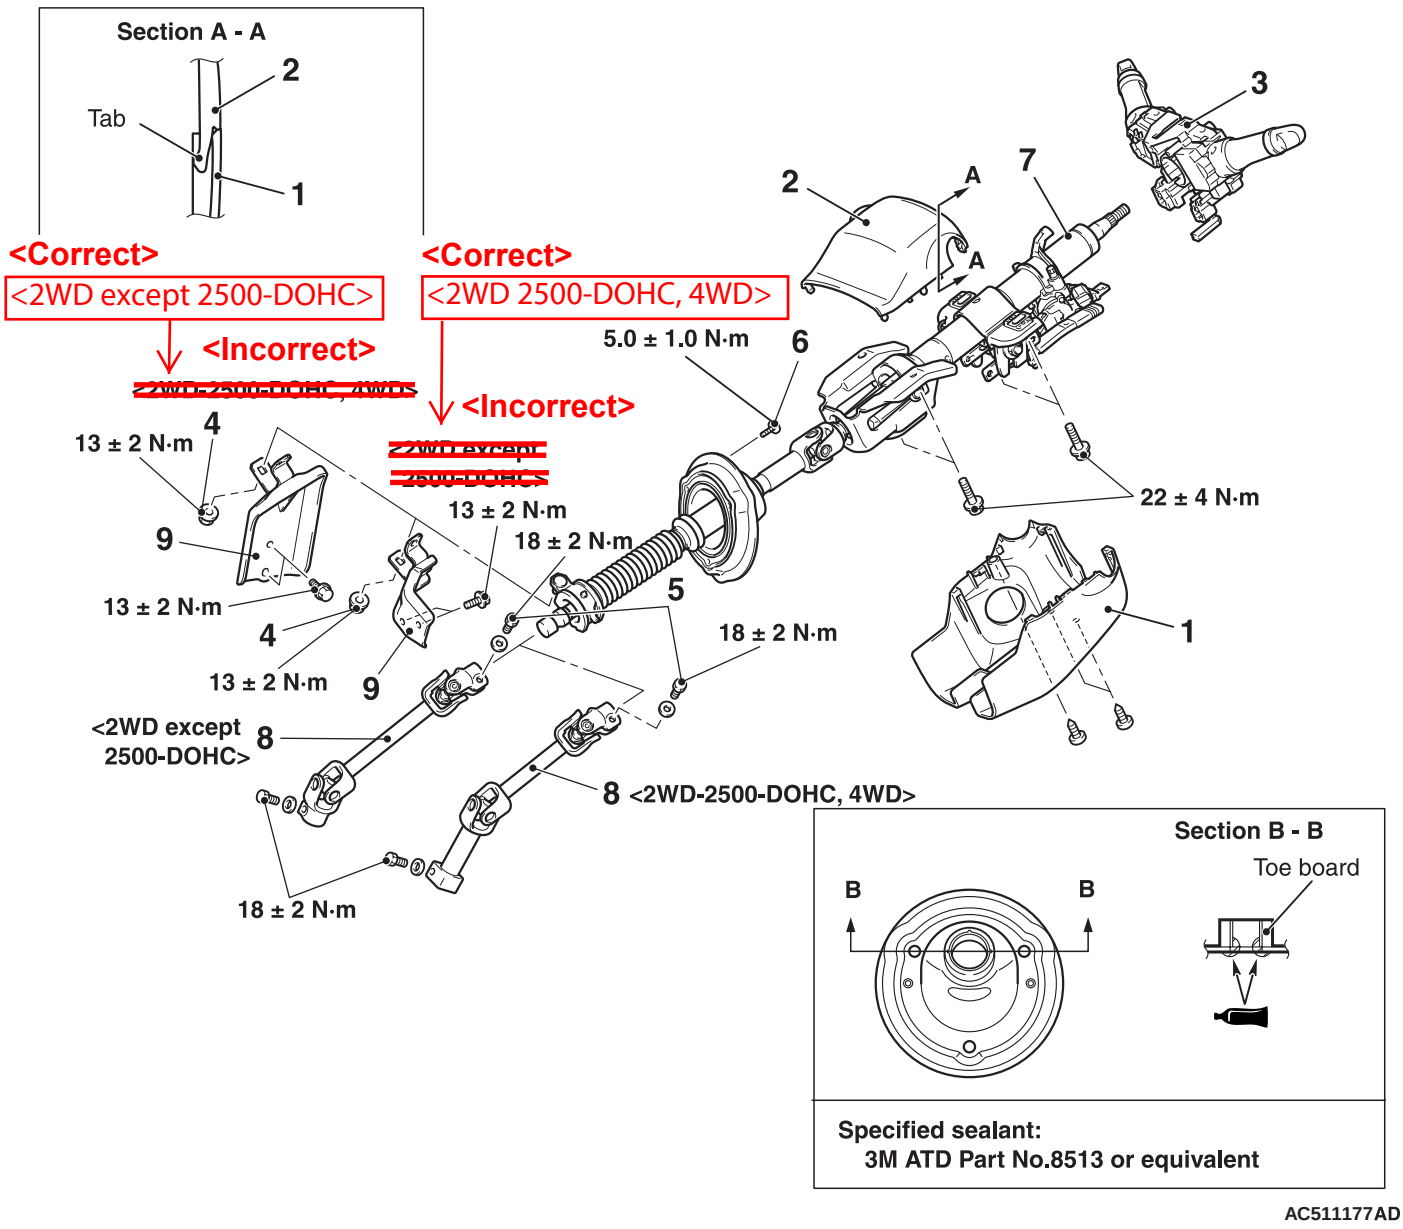
Attached sheet 3

<LH drive vehicles>

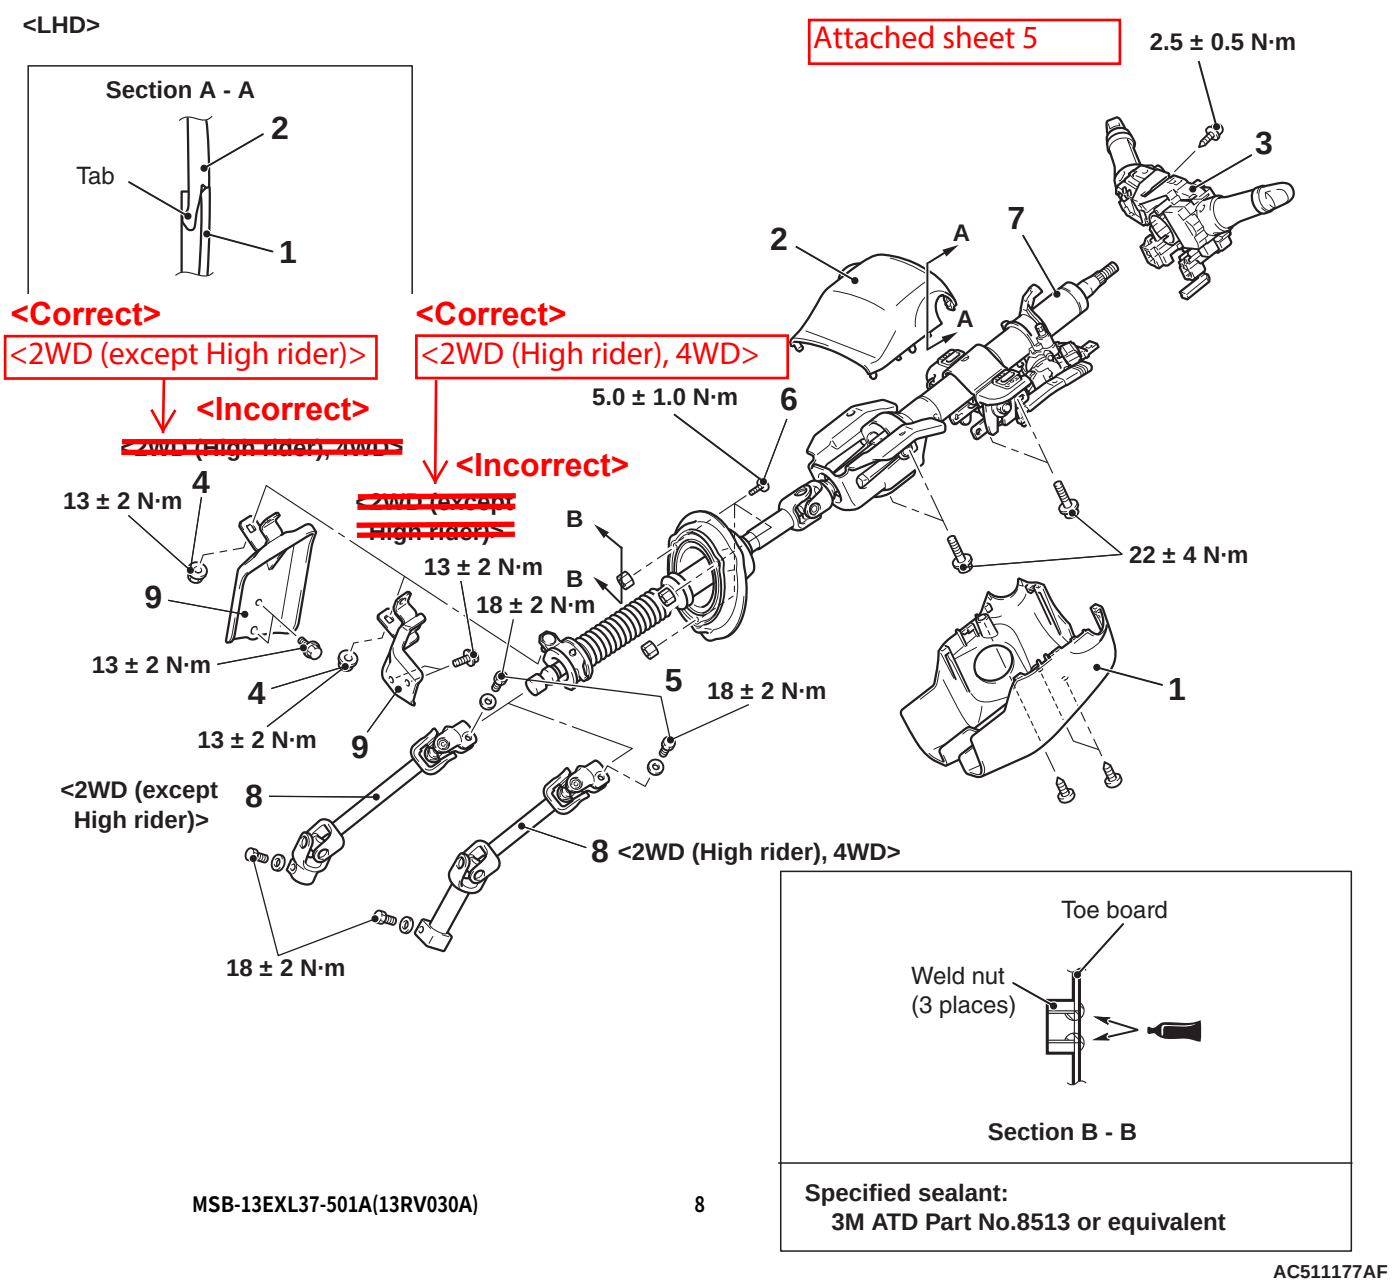
Attached sheet 5

<LHD>
